Carson City Airport Manager's Report Prepared by Corey Jenkins

Managers' Report

CARSON CITY AIRPORT AIRFIELD LIGHTING MAINTENANCE and UPGRADES OCTOBER 2020 – NOVEMBER 2024

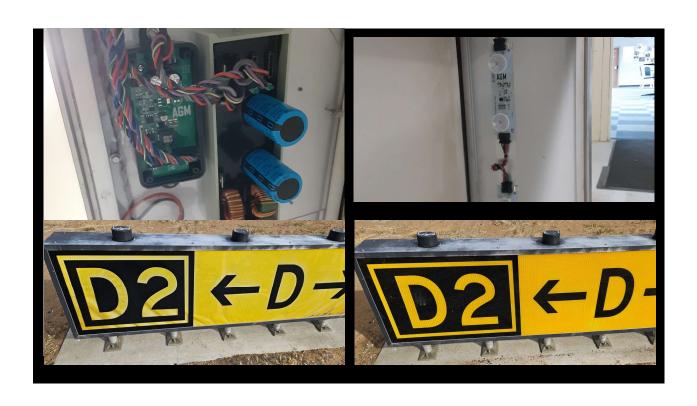
- Most of the signs on the airfield currently use incandescent (halogen) lighting. While the bulbs are still available, the transformers and control circuit boards are not. These items are proprietary to the sign manufacturer and are not available through other sources. When these items fail, the lowest cost solution is to install an L.E.D. retrofit kit.
- For kit installation, the sign assembly is removed from the airfield and brought to the maintenance workshop. All components are removed and replaced with the L.E.D. lights, drivers and control circuit boards. These are the same components used in signs currently in production. Installation takes 2-4 hours depending on size of sign.
- ➤ 6 L.E.D. RETROFIT KITS INSTALLED Kits cost \$600 \$1,000 each depending on size of sign.
